DOE/EA-1833D

**Floodplain and Wetland Assessment for the
Installation of a 20MW Solar Facility at
Chicago Rockford International Airport,
City of Rockford, Winnebago, Illinois**

September 21, 2011

JURISDICTIONAL WATERS DELINEATION REPORT
PROPOSED ROCKFORD SOLAR FIELD PROJECT
ROCKFORD, WINNEBAGO COUNTY, ILLINOIS

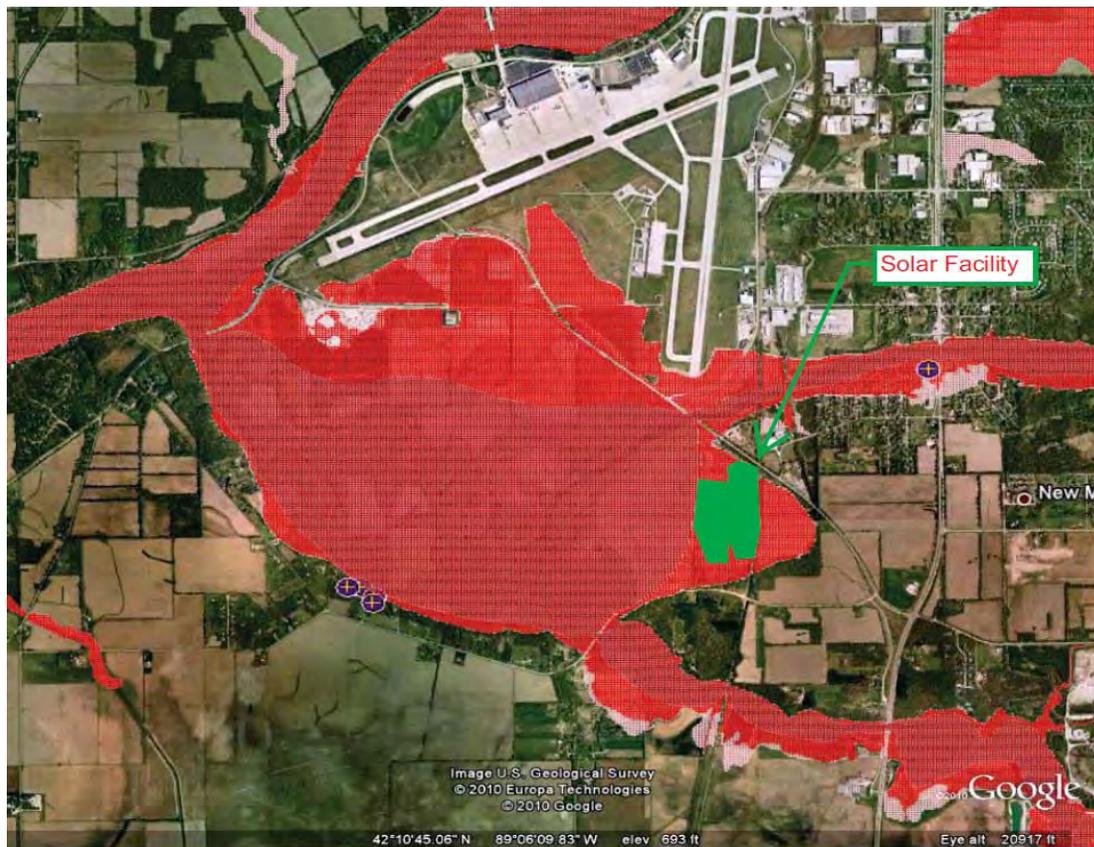
Figure 2, Rockford Solar Floodplain Map (National Flood Hazard Layer Web Map Service (WMS) in Google Earth™)

Pursuant to 10 CFR Part 1022, DOE reviewed the Federal Emergency Management Agency (FEMA) Flood Rate Insurance Map (FIRM). The 100-year floodplain occurs within the entire proposed project area; however the proposed project would not be located within the designated floodway of the Kishwaukee River. The regulatory floodway is defined as the channel of a river or other watercourse and the adjacent land areas that must be restored to previous grade in order to discharge the base flood without cumulatively increasing the water surface elevation more than a designated height. These features are depicted on Figure 2. To the west of the proposed project the Kishwaukee River begins to meander as it meets the low-lying areas that precede the confluence between the Kishwaukee and Rock River. These areas to the west are consistent of alluvial deposits from the Kishwaukee River and are comprised entirely of Forested and Emergent Wetlands.

The majority of the proposed project site is at or near the 700' BFE which delineates the floodway from the floodplain. No fill material would be brought onto the proposed project site and no fill material would be generated from the proposed construction. Tree removal would occur along the Northeast of the site's boundary as necessary (Figure 1). Limited quantities of hazardous materials would be used and stored on-site for Operations & Maintenance. These materials may include lubricants, solvents, janitorial supplies, office supplies, paints, degreasers, gasoline, hydraulic fluid, propane, and welding rods. These materials would be stored, used, and disposed of in accordance with all applicable local, state, and Federal laws and regulations. All flammable materials (ie. paints and solvents) would be stored consistent with state and federal regulations.

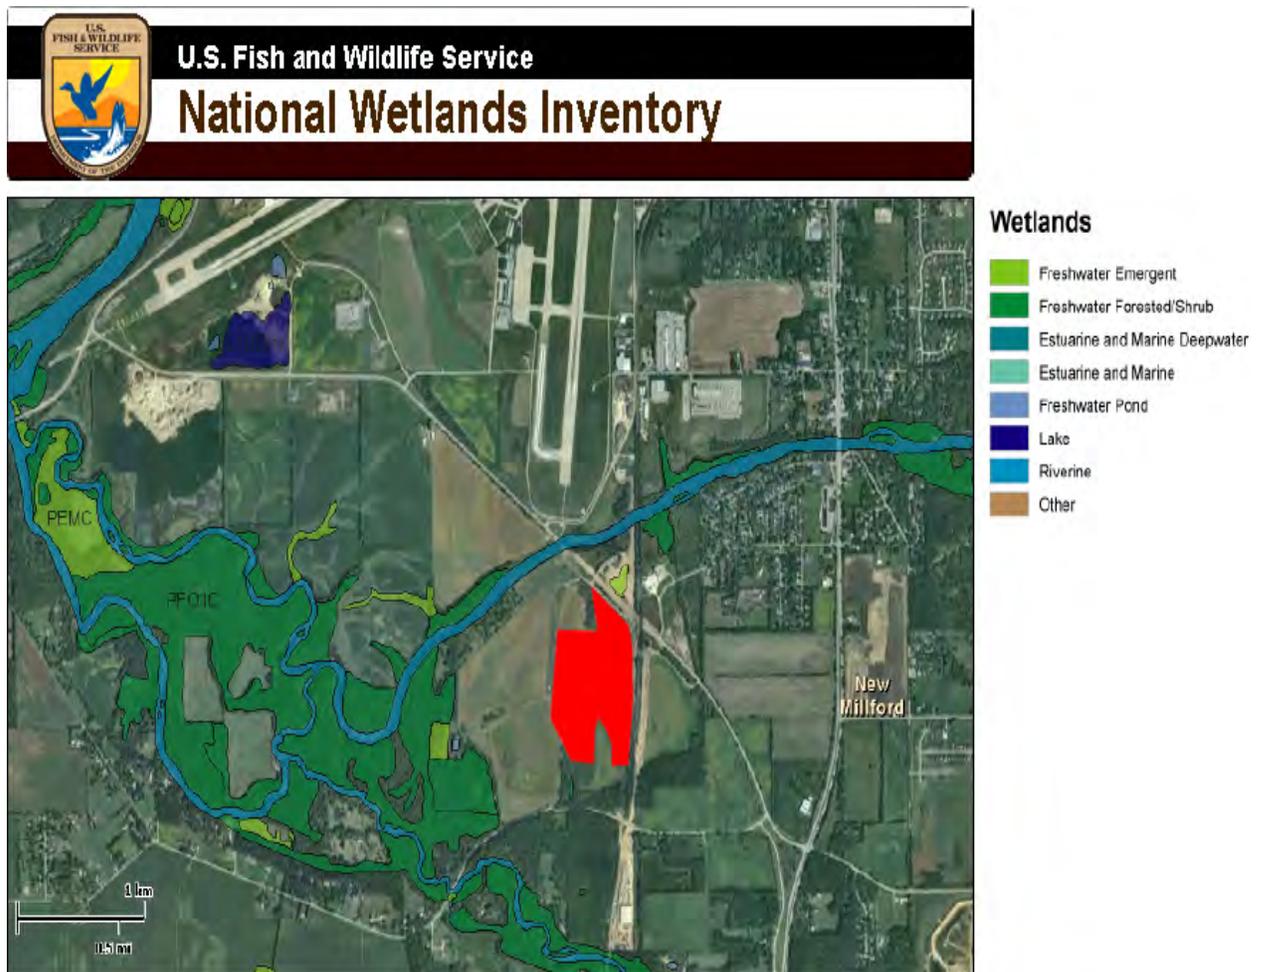
Figure 3, Rockford Solar Wetlands Map (USFWS National Wetlands Inventory-Wetlands Mapper)

Also pursuant to 10 CFR Part 1022, DOE reviewed the USFWS National Wetlands Inventory (NWI) map. According to the USFWS NWI Map (Below), there are no wetlands located in the immediate proximity of the proposed project area. However, Rockford Solar Partners prepared a Jurisdictional Waters Delineation Report for the Proposed Rockford Solar Energy Project. Although the US Army Corps of Engineers (USACOE) has not concurred on their findings, RSP concluded that approximately 30.6 acres of both Forest and Emergent wetlands exist within the property boundaries, of which 21.9 were interpreted through field reconnaissance. Based on the review of this report, DOE has concluded that no wetlands are located within the proposed limits of disturbance associated with the proposed project. However, based on aerial imagery, there appears to be a emergent wetland in the vicinity. Figures 2 and 3 provide the results of the wetlands inventory.

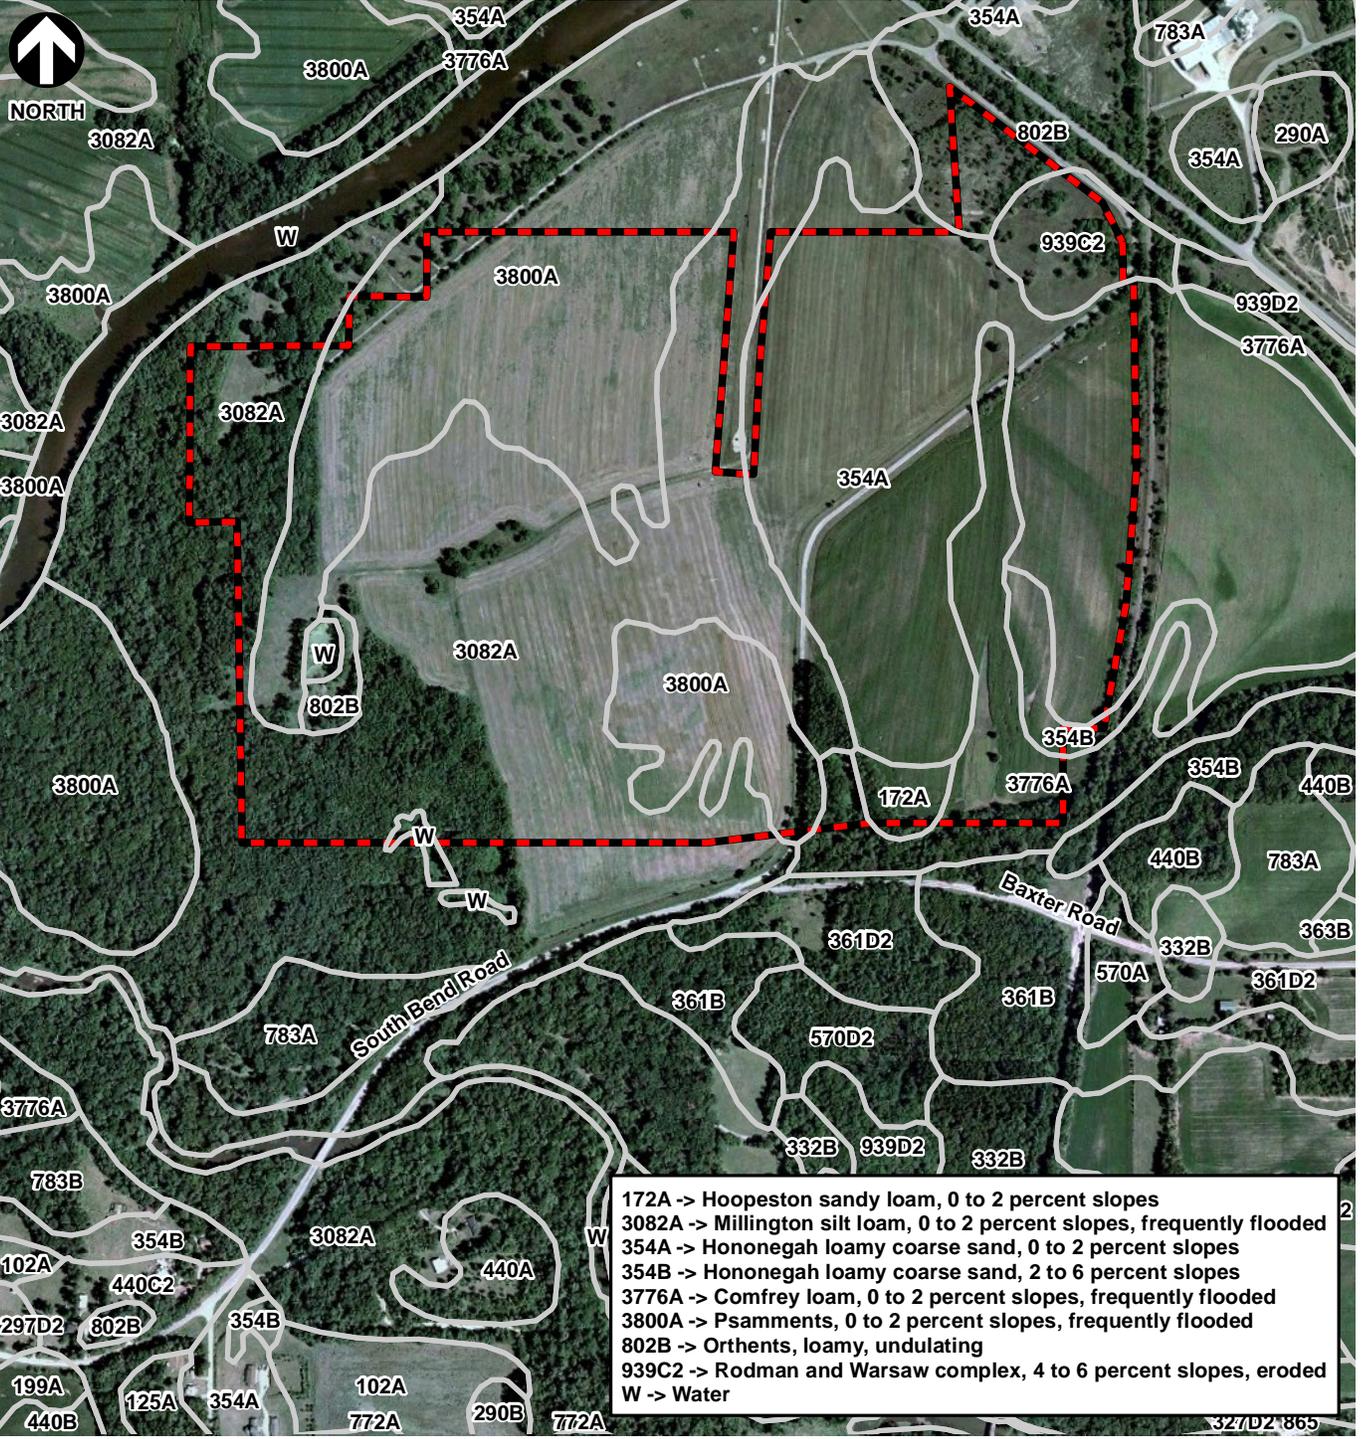
172A -> Hoopston sandy loam, 0 to 2 percent slopes
 3082A -> Millington silt loam, 0 to 2 percent slopes, frequently flooded
 354A -> Hononegah loamy coarse sand, 0 to 2 percent slopes
 354B -> Hononegah loamy coarse sand, 2 to 6 percent slopes
 3776A -> Comfrey loam, 0 to 2 percent slopes, frequently flooded
 3800A -> Psamments, 0 to 2 percent slopes, frequently flooded
 802B -> Orthents, loamy, undulating
 939C2 -> Rodman and Warsaw complex, 4 to 6 percent slopes, eroded
 W -> Water

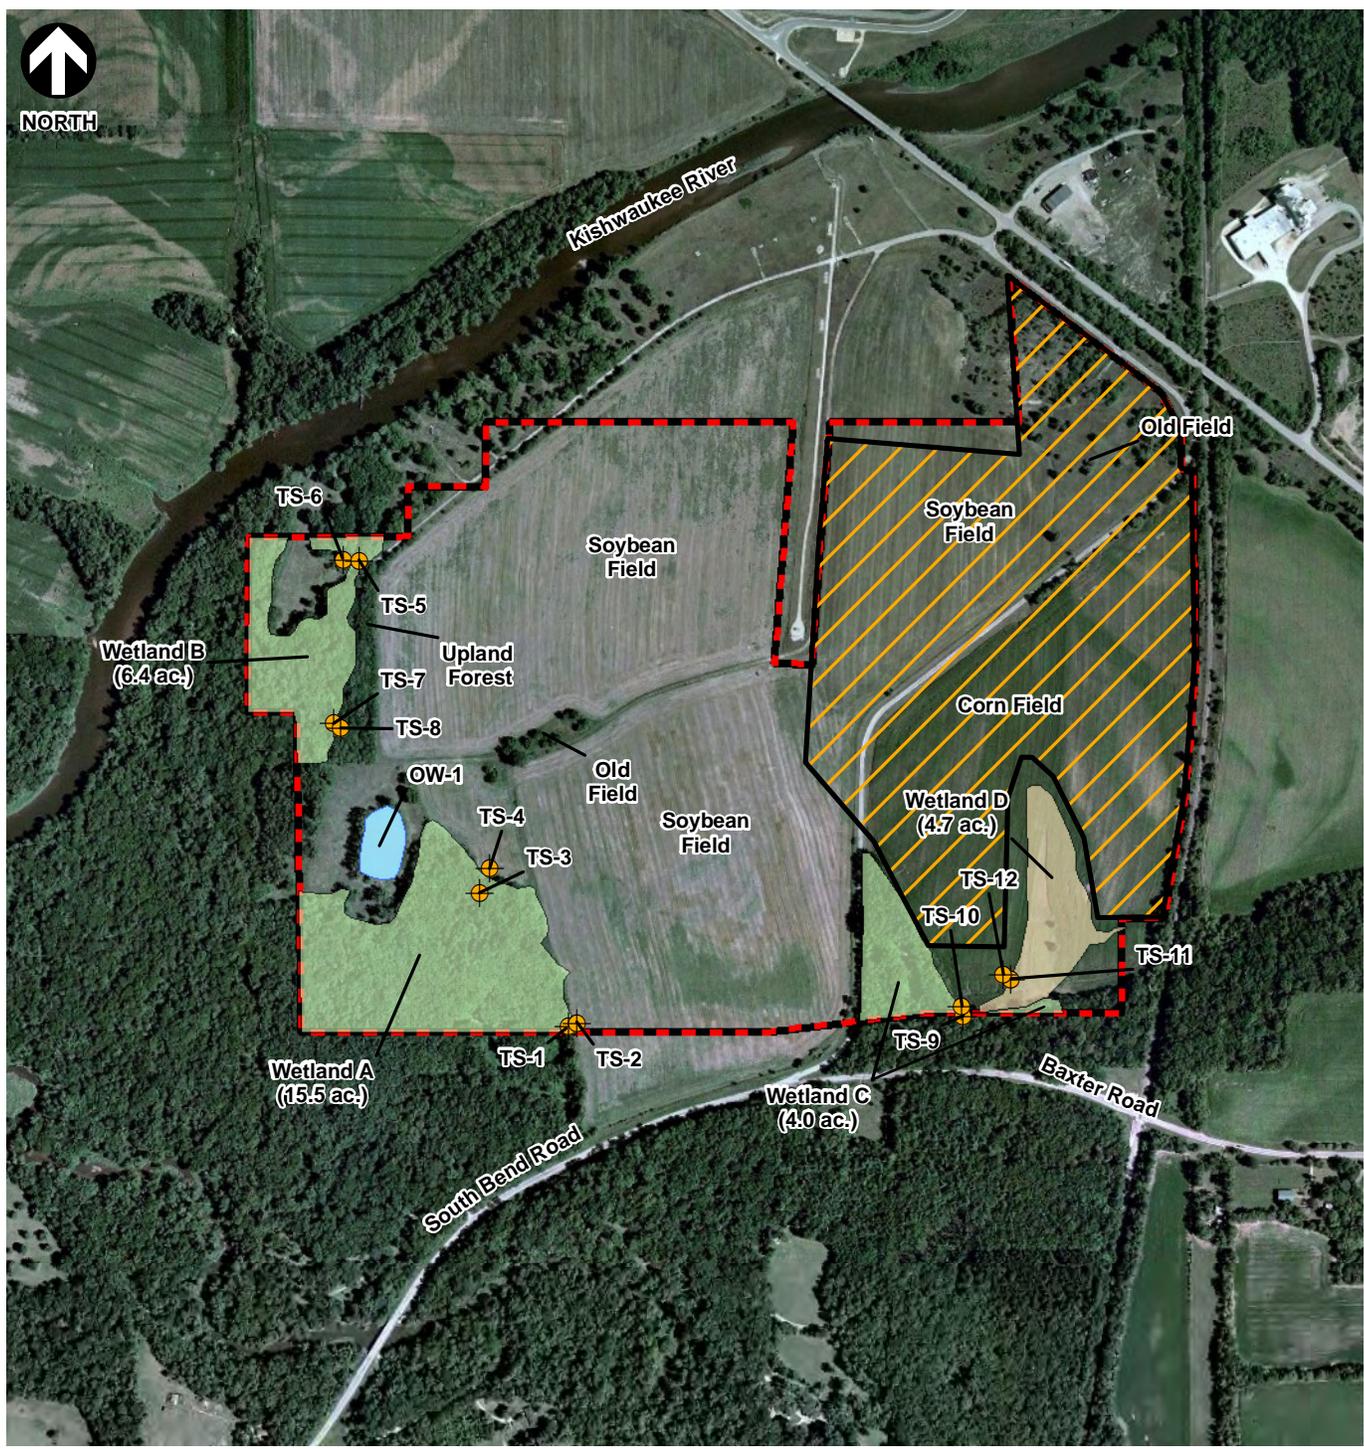
- Wetland Determination Test Pit
- Approximate Open Water Boundary
- Proposed Limits of Disturbance
- Approximate Site Boundary
- Emergent Wetland
- Forested Wetland
- Approximate Wetland Boundary

SOURCE:
 WETLANDS DATA OBTAINED FROM CEC WETLAND SURVEY CONDUCTED ON JULY 6 & 7, 2010.
 PORTION OF A THE ESRI IMAGE WEBSERVICE - "WORLD_IMAGERY" - "AERIALS EXPRESS CHICAGO 2007."

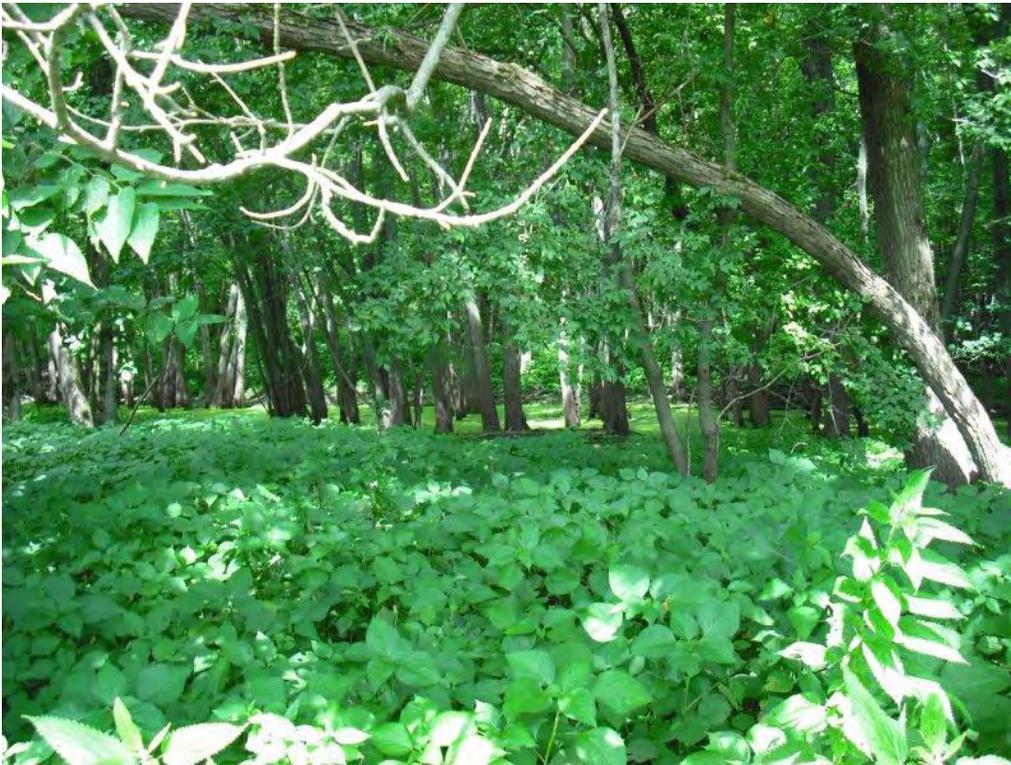
Photo 2 – Representative view of Wetland A. Photo taken facing west.

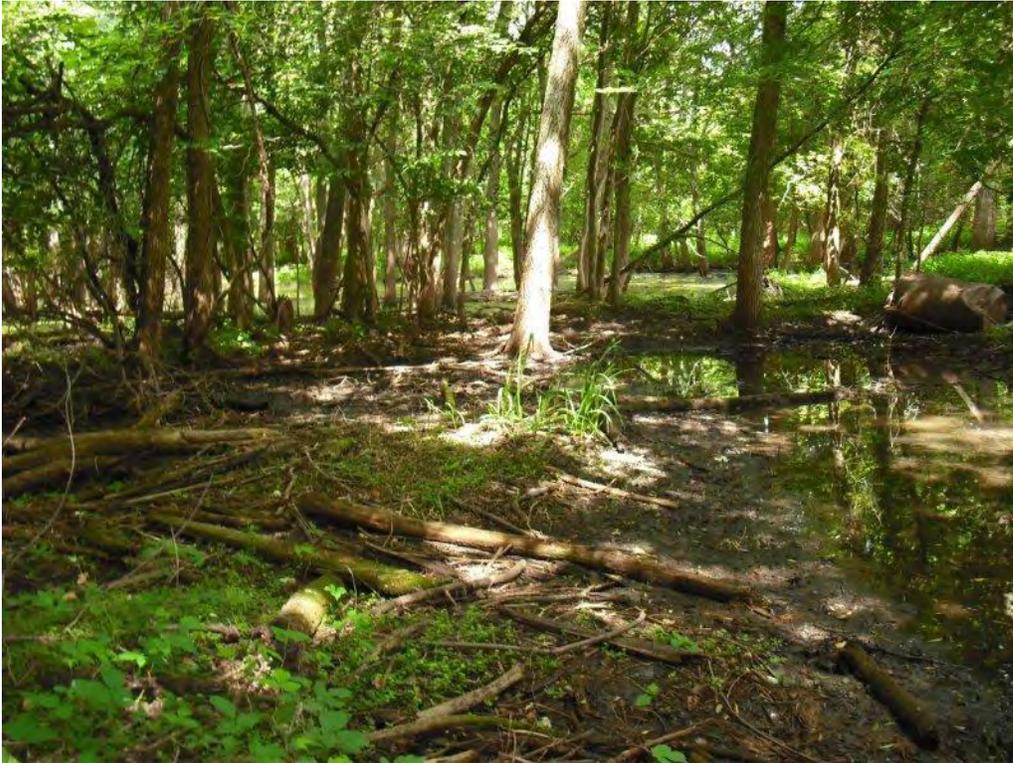
Photo 3 – Representative view of Wetland A. Photo taken facing north from TS-3.

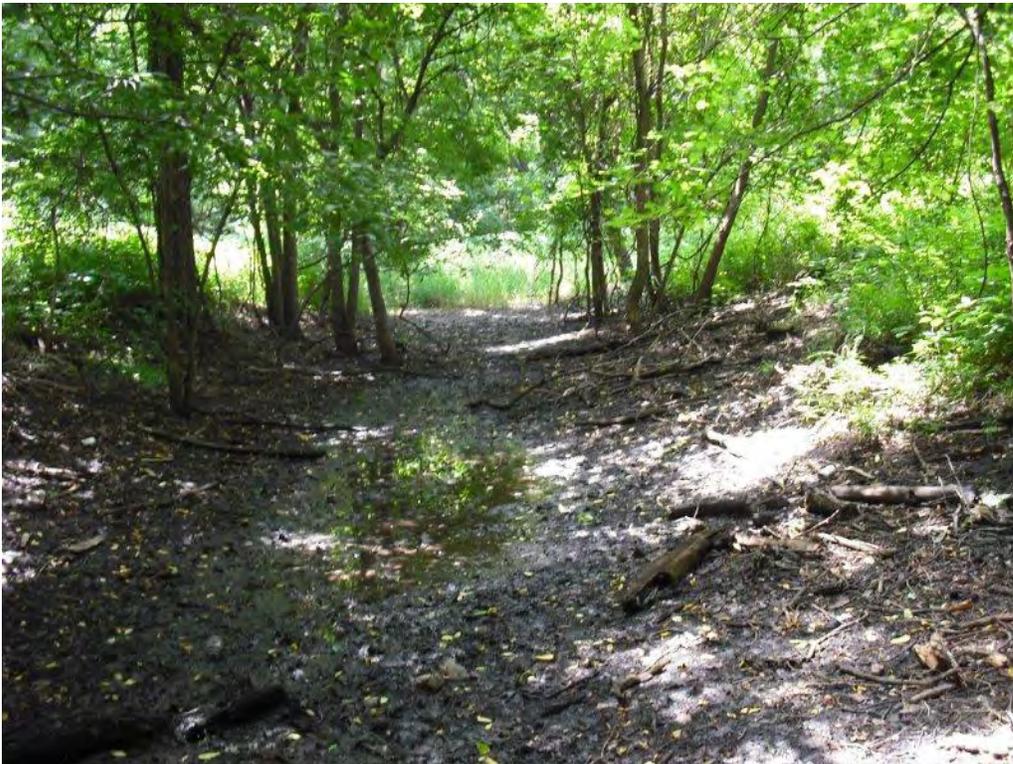
Photo 6 – Representative view of Wetland B. Photo taken facing south.

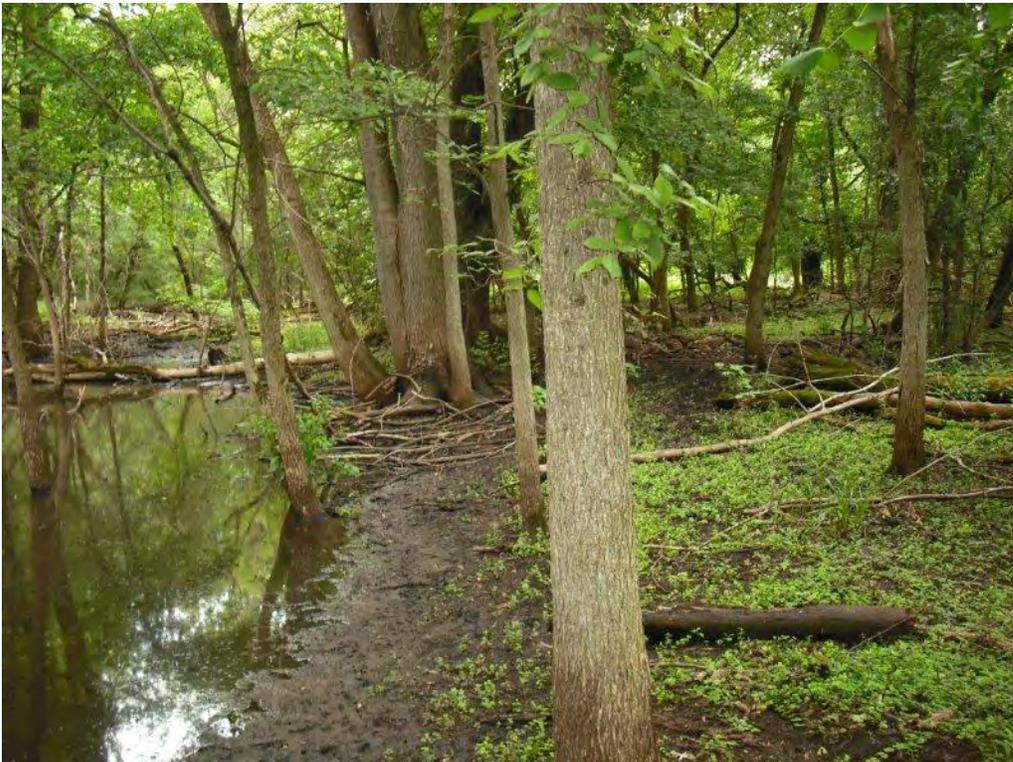
Photo 10 – Representative view of Wetland C. Photo taken facing west.

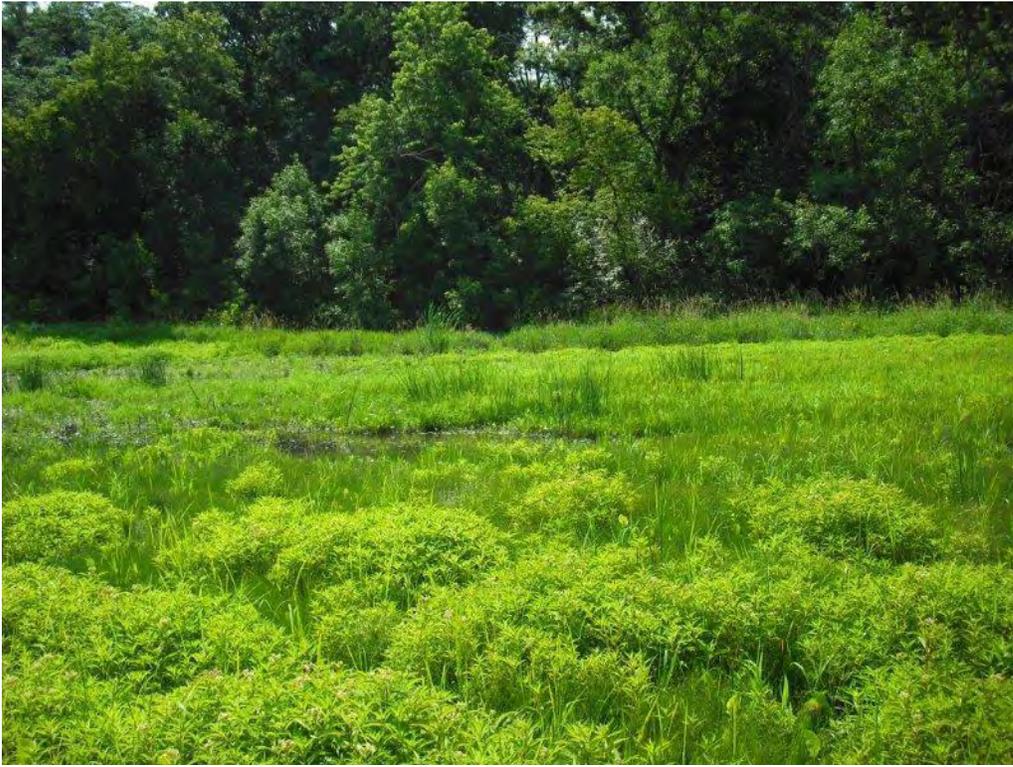
Photo 13 – Representative view of Wetland D. Photo taken facing south.
