APPENDIX D CAMP GEORGE WEST HISTORIC DISTRICT

Camp George West is a Colorado Army National Guard installation located in central Jefferson County, Colorado, approximately 3 miles east of the City of Golden and 10 miles west of downtown Denver. The facility is situated in an unincorporated area known as Pleasant View, with the City of Golden to the west and the City of Lakewood to the east.

Camp George West Historic District was listed on the National Register of Historic Places (NRHP) in 1993 (NRHP 2008). This appendix discusses the district's location and setting, background, and historic significance, then describes the resources within the district boundaries that could be affected under the Proposed Action.¹

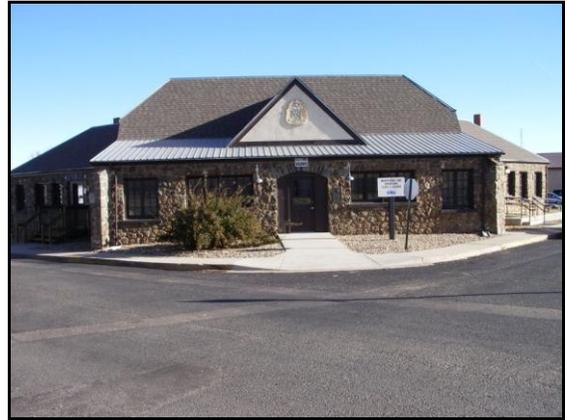
Headquarters (Building 45)

A focal point of the post is the headquarters building erected in 1937 with funding from the WPA. The building was designed by George H. Merchant to employ as many hours of labor as possible in its construction, thereby providing employment for public relief workers. Included in the design were a complex roofline, many windows, and several wall projections. The one-story split fieldstone building has a central bay with a steeply pitched roof intersected on each end by roof wings. The central bay has a low, shed-roofed projecting façade presenting the building's central entrance. Above the entrance is a pediment arch that is stuccoed and decorated with the state seal. The entrance is flanked by a pair of casement windows with concrete sills. Flanking these are large 16-pane windows.

At the corners of the main bay are engaged stone pilasters. In 1956, a frame addition was added to the eastern wing of the building. The main entrance has been remodeled, as have entrances on the east and west wings.

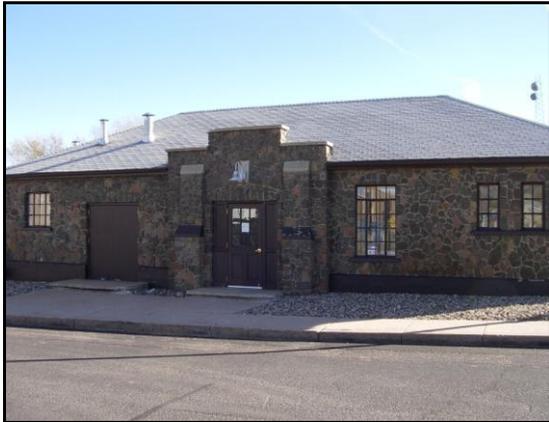
Guardhouse (Building 83)

The guardhouse was one of the WPA-funded projects which erected major administrative and support buildings around the central quadrangle of the post. George H. Merchant designed the building to employ a maximum amount of labor through the inclusion of numerous windows and wall projections. The one-story, randomly coursed, split stone building has a pitched roof. A central, slightly projecting entrance features a stepped parapet with cast cement coping. Flanking the entrance are engaged stone pilasters with cast cement trim. Stonework above the entrance opening forms a slight arch. Windows are multi-pane casements with cast sills. The building has a raised concrete foundation, which has been painted. The original main entrance has been enclosed and has a window. The east elevation has an enclosed entrance bay with nonhistoric siding.

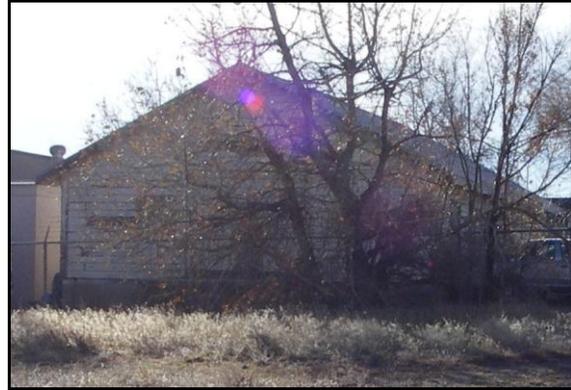
Small Arms/Ammunition Storage (Building 33)

This one-story rectangular frame building has tongue-and-groove siding and a gabled roof with overhanging eaves and exposed rafters. The northern elevation has a central sliding wooden door that opens onto a small loading dock and is flanked by small multi-pane windows. A second sliding door is on the west. Windows are mostly six-pane with wood trim. One window on the east elevation has been replaced with a metal vent.

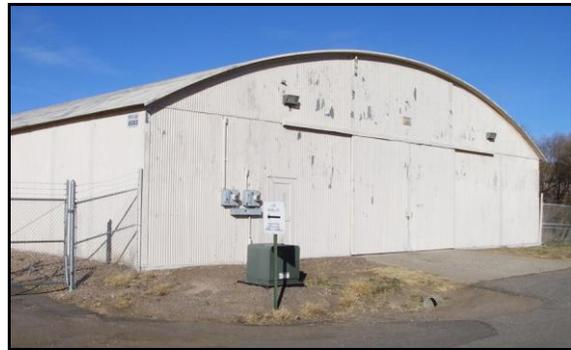
Motor Vehicle Storage (Building 111)

Built in 1953, after the period of significance (1903 to 1945), Building 111 was constructed north and west of the Headquarters and Guardhouse. This quonset-hut-style building has been designated a noncontributing resource, meaning it lacks any associations, qualities, or values that would contribute to the significance of the Camp George West Historic District.

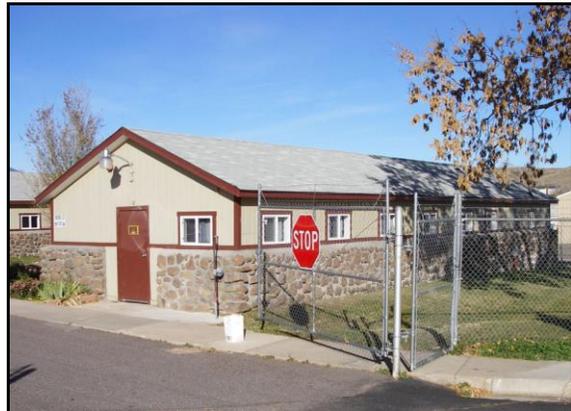
Mess Hall (Building 12)

This building is one of 11 remaining of 17 mess halls built during the period 1936-1941 on the post. It is representative of the current appearance of the buildings. This mess hall is a one-story front gable building with overhanging eaves. The lower portion of the building to sill height is composed of quarried basaltic stone rubblework; the upper walls are frame, now covered with nonhistoric siding over the original horizontal tongue-and-groove siding. The building has central entrances on gable end walls. The south entrance originally had double doors but now has a single door. Side elevations had central doors that are now covered up. Original six-pane windows have been replaced with sliding windows. Original corrugated iron roofing has been replaced with shingle roofing.

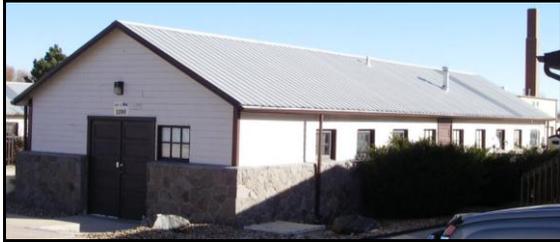
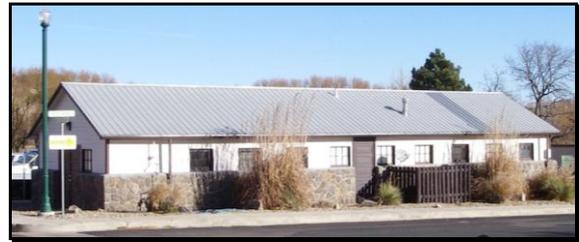
The basic design of these mess halls, built approximately 5 years after Building 12, was essentially the same as the design for Building 12. However, the stone masonry on the lower portion of these buildings is more polygonal, with the stones quarried to a flatter surface.

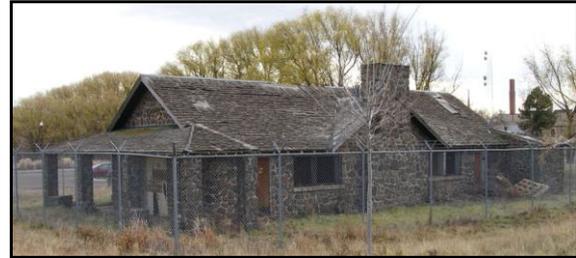
Recreation Hall (Building 48)

This one-story building was designed to accommodate leisure-time activities of Guardsmen as a WPA public works relief project. The walls of the building are composed of fieldstone set with wide mortar seams. The cross-gabled roof has widely overhanging eaves, decorative beams, and exposed rafters. A projecting, gabled, central entrance bay is flanked by wraparound porches with stone pillar supports and walls. Over the entrance is a flat stone lintel. All windows have multiple panes (six or eight) and cast cement sills. The interior features a large fieldstone fireplace. The building has nonhistoric doors, the windows have metal grills, and a portion of the porch has been enclosed.

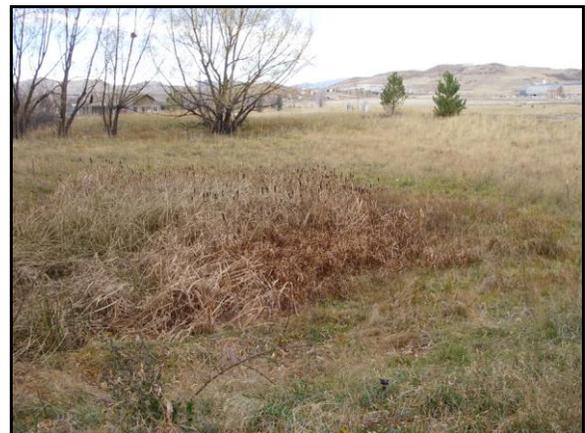
The concrete outdoor swimming pool is no longer in existence; in its place is a wetland. The pool, built as a public works relief project, was a 50- by 90-foot rectangle that varied in depth from 3 feet on the western shallow end to 8 feet on the eastern end. The edge of the pool was surrounded by a narrow wall approximately 18 inches high, which was topped by a flat concrete top. An L-shaped concrete bench was located northwest of the pool. The pool originally had a diving board in the center of the east end and metal access ladders adjacent to the diving board and at the northeast and southeast corners. The pool was enclosed by a chain link fence.

Wetland occupying the original location of the outdoor swimming pool (Structure 49)

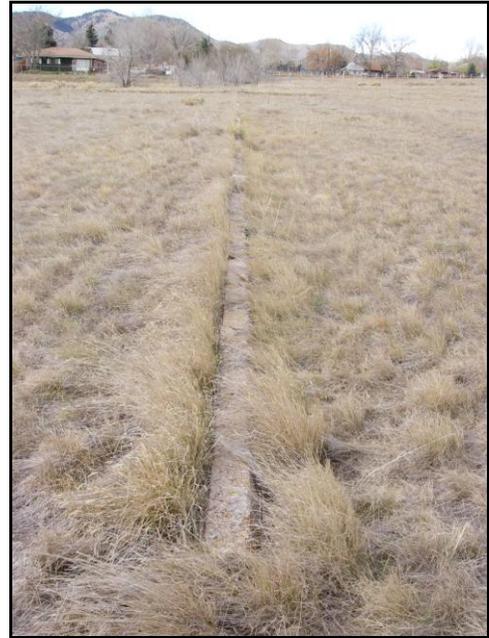
Rifle Firing Range (FR12)

Located northwest of the principal concentration of buildings at Camp George West, on the western edge of the installation, the lines of the firing range are oriented east-west and consist of a 600-yard line (farthest to the south), a 500-yard line, a 300-yard line, and a 200-yard line (farthest to the north). The lines are constructed of concrete, approximately 340 feet long and 1 foot wide, flush with the ground on the side of the shooter and about a foot above the ground on the side of the target. The 600-yard line is intact; the remaining three are missing segments where a dirt road and/or channelized drainage cuts through the lines. The rifle range was utilized during summer encampments of the Colorado National Guard during the 1920s and 1930s. During World War II, the 757th Military Police Battalion used the range.

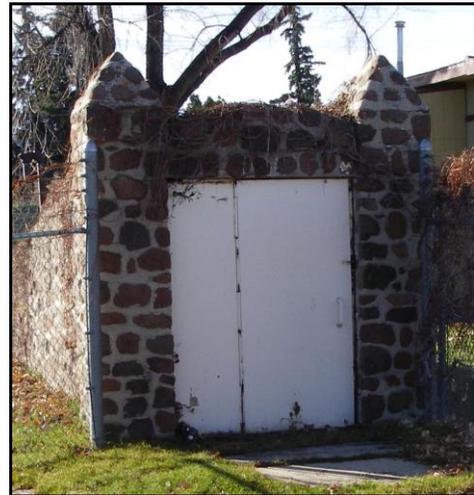
Pedestrian Underpass (Structure 50)

A Civil Works Administration project completed this pedestrian tunnel under South Golden Road and the Denver and Inter-Mountain railroad tracks to connect the northern and southern portions of the camp. The concrete-lined passageway consists of steps and a tunnel with sloping floors toward a level midsection. Entrances on either end are wedge-shaped and composed of split fieldstone. Stone posts with pyramidal tops stand at the corners of the entry and extend beyond the roofline. The roof is slightly curved and covered with a thin layer of concrete. The entrance on the southern end is open, while the one on the north is covered with a metal door and siding.

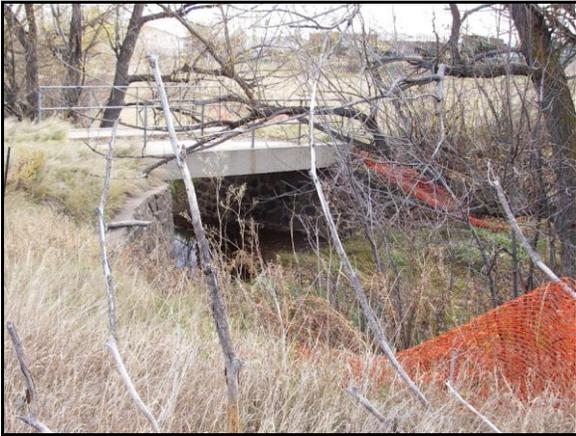
Bridge (Structure 92)

This bridge over Lena Gulch was built as part of the WPA project to improve the post and provided easier access to the northwest quadrant of the camp and firing range. The one-lane bridge has a reinforced flat concrete deck and a 10-foot roadway with a 3-foot sidewalk on the east. The span of the bridge is 14 feet. The bridge abutments are composed of roughly split basaltic stone laid in courses. The side walls of the bridge are flared, rounded, and tapered and have a top layer of concrete.

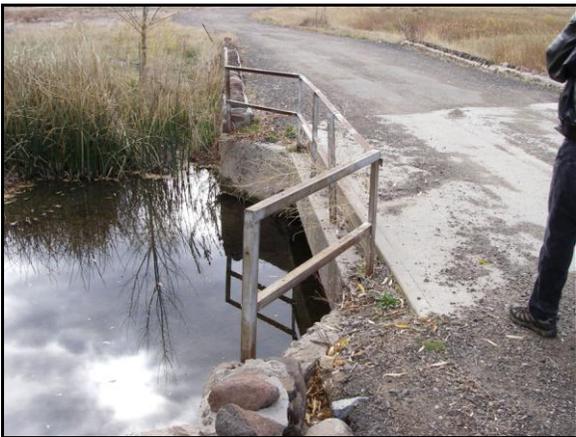
Bridge (Structure 113)

This two-lane bridge in the north-central section of Camp George West was constructed in 1938 as a WPA project. The bridge separately spans Lena Gulch and an unnamed tributary to that stream. It has a reinforced concrete slab deck and split fieldstone abutments with thick mortar. The roadway is 20 feet wide with stone walls higher toward the center of the bridge, where the land drops off beneath. A layer of projecting fieldstones is cemented to the top of the bridge walls, and metal railings flank the bridge deck. The total length of the bridge and its approaches is approximately 140 feet.

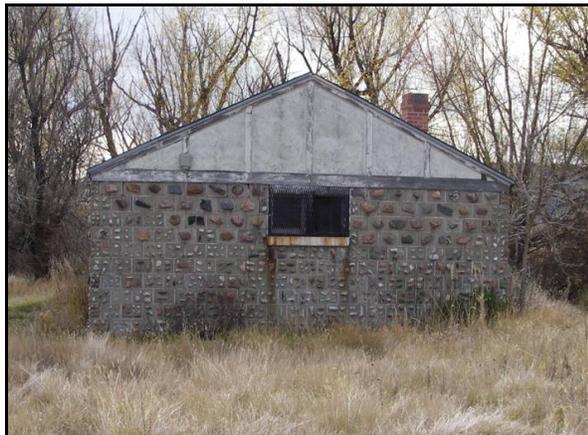
Golden Gun Club Clubhouse (Building 104)

This small one-story gabled building was composed of hand-made concrete blocks with decorative rocks embedded in them in decorative patterns. The building was not built by the military, and the National Guard did not take possession of the building until 1948; therefore, it does not meet the requirements for a contributing resource within the district. This building was destroyed by fire the weekend of July 25-26, 2009.
